Field visit to lower Icicle Creek on July 2, 2015, to evaluate habitat enhancement opportunities

Attendees: Jim Craig (US Fish and Wildlife Service), Jeremy Cram (WA Dept. of Fish and Wildlife), Mike Kane (Chelan Co. Natural Resources), Ericka Hegeman (Chelan Co. Natural Resources)

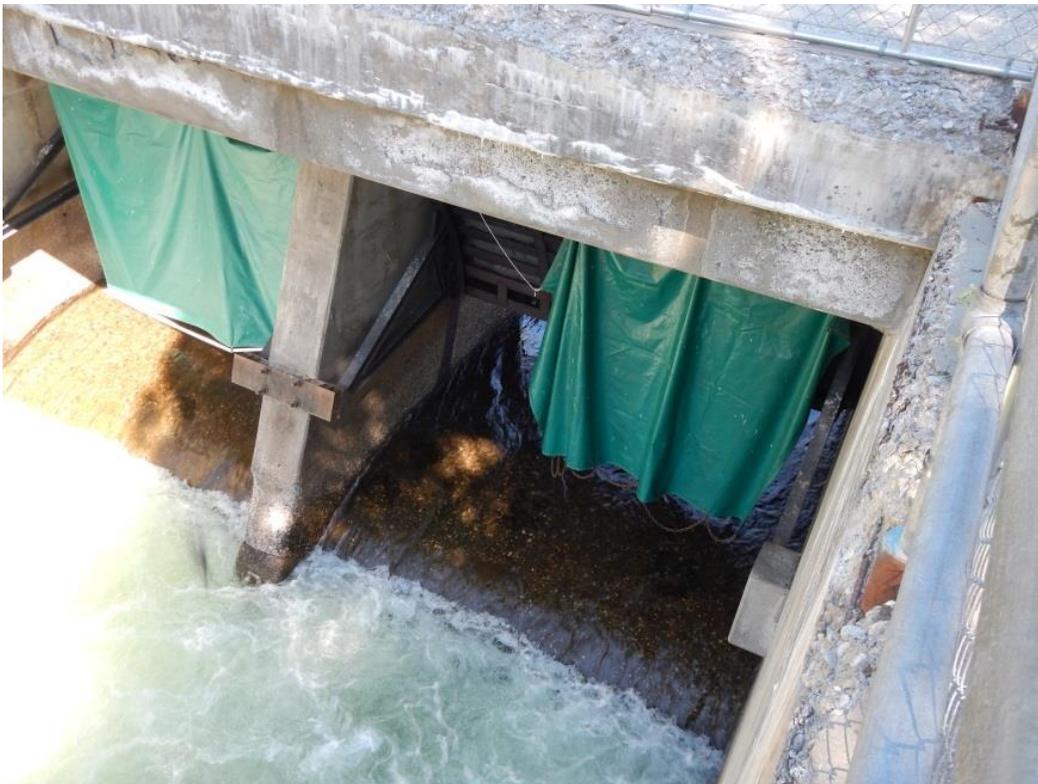
- a. Current operation based on BiOp. Long-term goal to eliminate operation for groundwater recharge. IWG recommendation of max 2,600 cfs to preserve habitat function in historic channel.
- b. Description: Possible large rock structure downstream of dam to induce and/or maintain existing scour hole
- c. Feasibility: Unlikely location for habitat work due to head gate maintenance, tribal fishing location, landowner access

Figure 1 Head gate dam with migration curtain

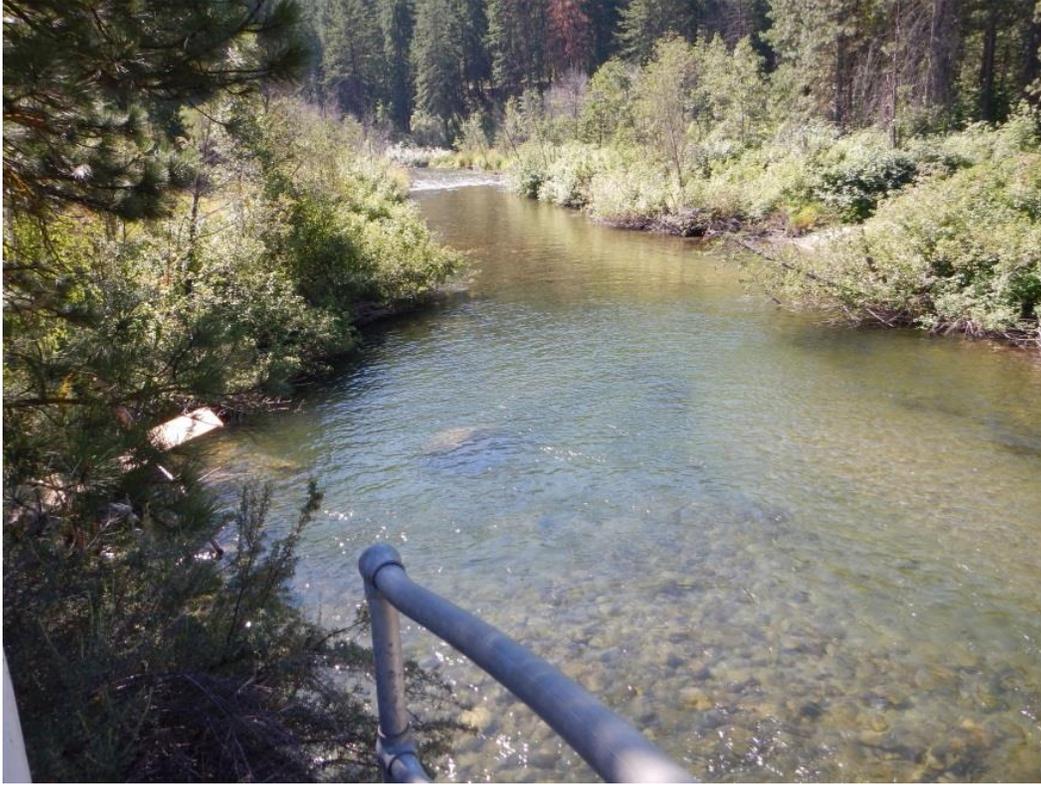
Figure 2 Downstream of head gate dam (Structure 2), location of possible scour hole and current tribal fishing location

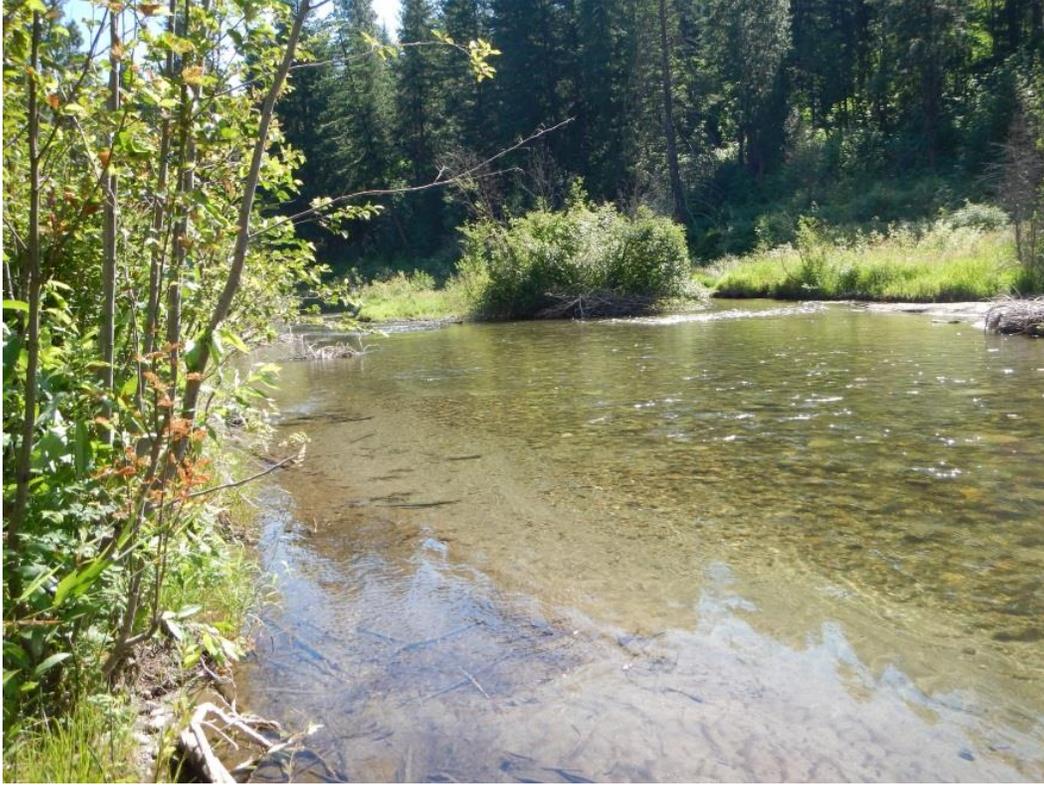
- a. Current condition: Very functional side channel habitat providing coho spawning and rearing. Some Chinook (hatchery) spawning and rearing is also present.
- b. Description: Due to lack of large wood recruitment into side channel, one project discussed would be to thin out some trees on USFWS property and possibly private property on right bank (Copper Notch) and fly whole trees with rootwads into channel rather than building large ELJ structures.
- c. Feasibility: Use excavator to remove on-site trees and move with helicopter, maybe 20-30 trees. ~\$60-70K

Figure 3 Historic channel, looking downstream

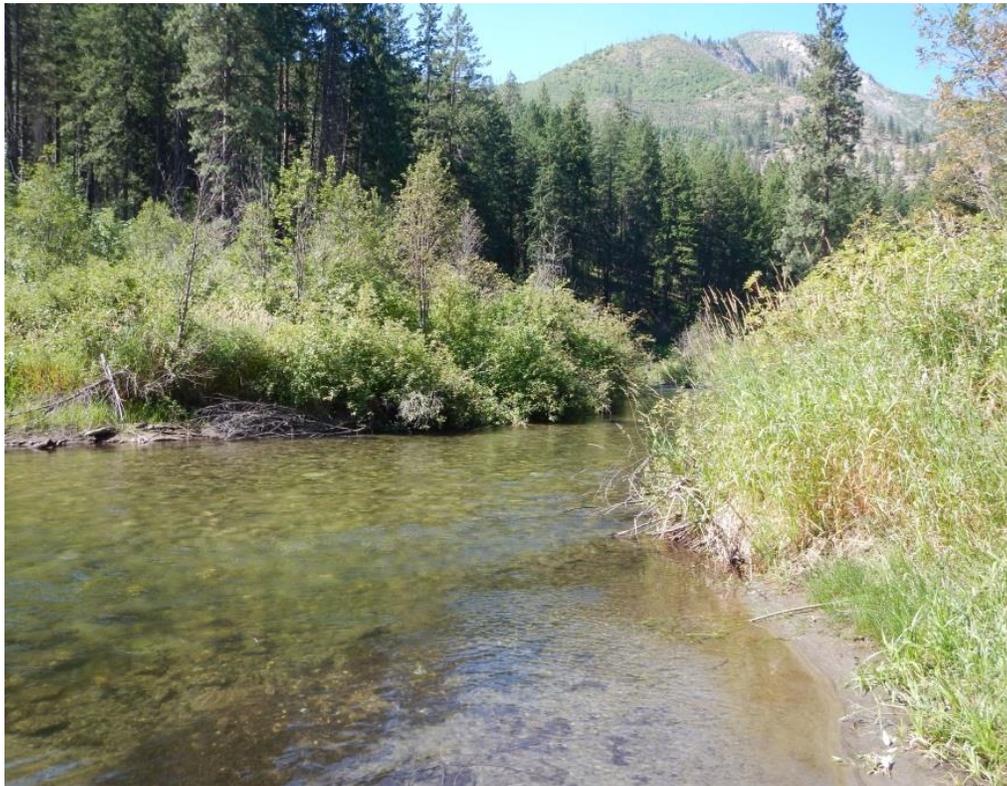
Figure 4 Historic channel, looking upstream

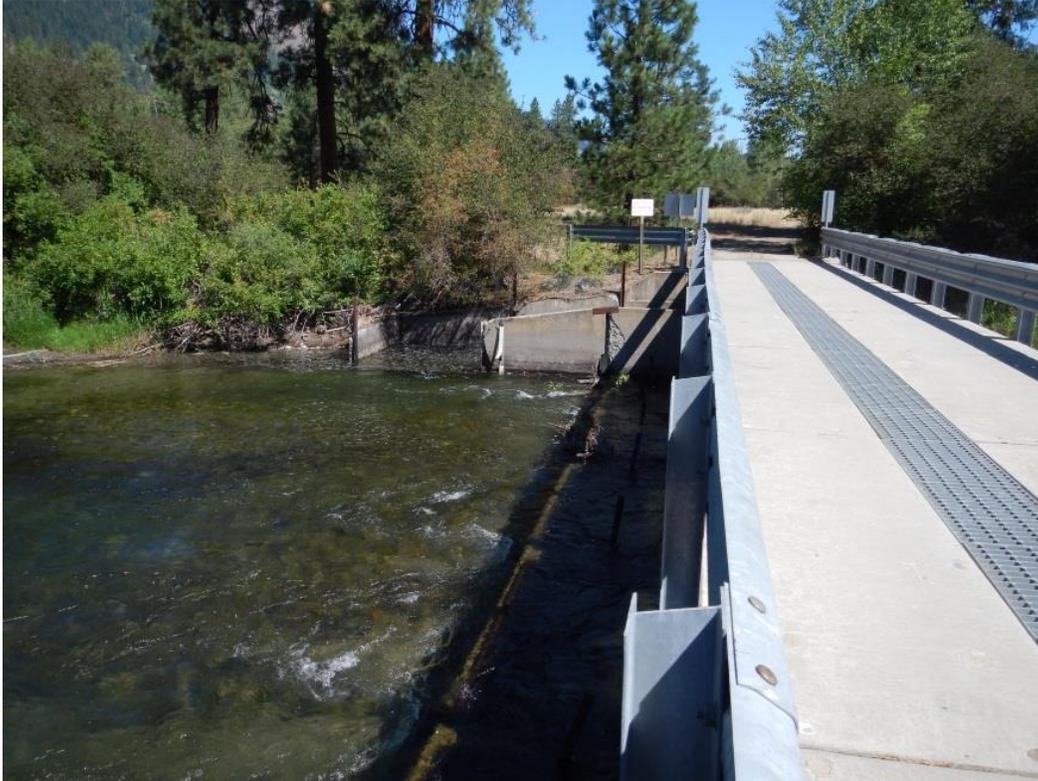
Figure 5 Structure #5

- a. Current condition: Channel-spanning structure. Pickets used when 50 spring Chinook pass during broodstock collection.
- b. Description: Removal of structure and replacement with grade control structure, ELJ's, possible fishing platform, plantings, ~\$300K+.
- c. Feasibility: Probably most interesting project to consider within this reach but require details to sort out with tribal fisheries, bridge access, etc.

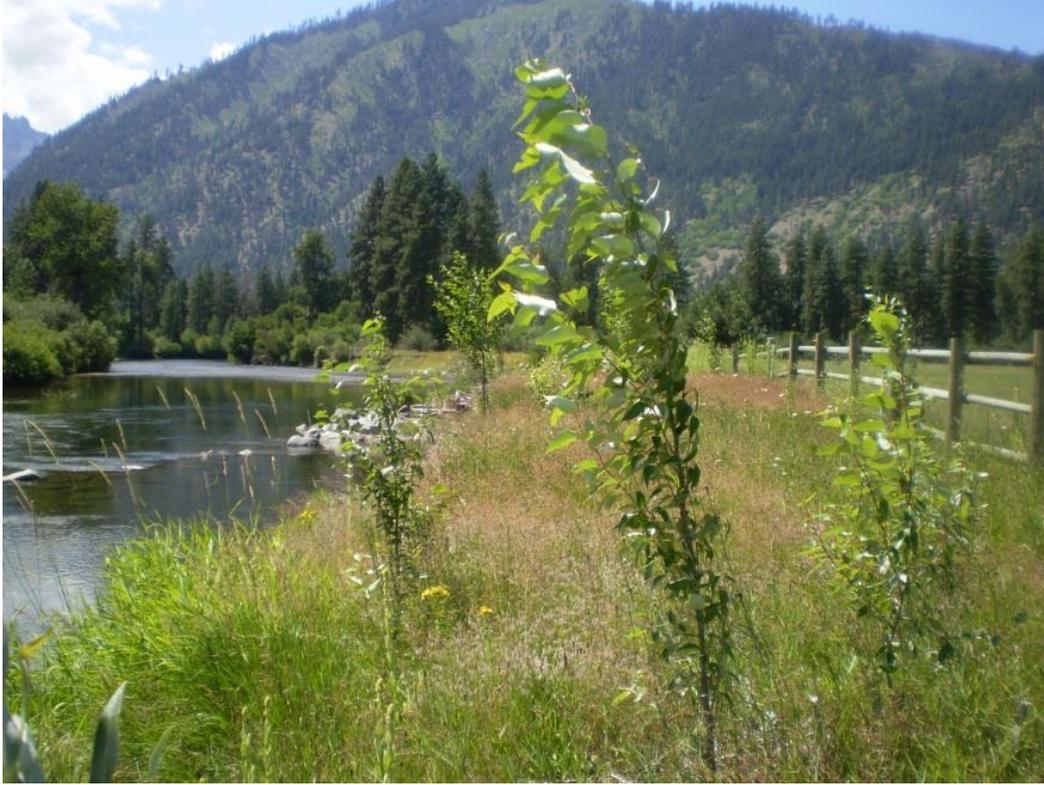
- a. Current condition: High width to depth ratio.
- b. Description: A geomorphic assessment could be used to document existing conditions and identify the opportunities and constraints of habitat improvements. For example, using large rock and or wood to reinforce existing islands, develop thalweg and reduce overall channel width.
- c. Feasibility: There appear to be limited opportunities upstream of the Fromm property based an existing land use, armoring and recreational use. Opportunities within the Fromm-owned reach would have to accommodate landowner use and spring and summer recreation use.

Figure 6 Icicle Creek at Fromm property (photo taken 2008)
