E ECHELON ENGINEERING, INC.

Civil/Marine Consulting Engineers

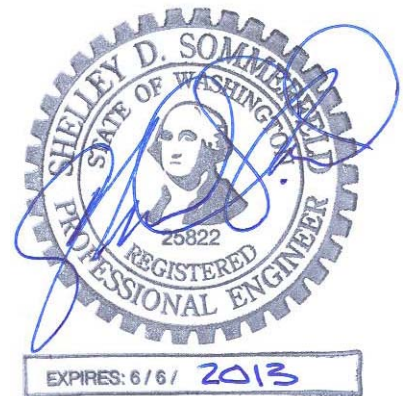
Underwater Inspection Report

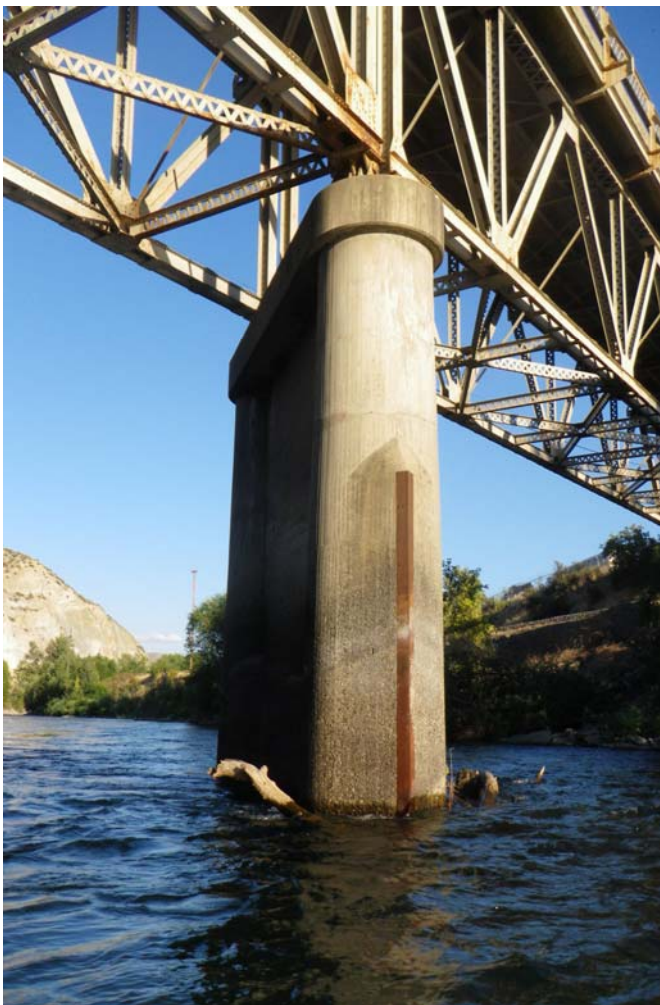
PHOTO No. 2: Pier 5, Looking East -
Inspection of the pier found
the concrete to be sound
and in good condition. Note
the embedded steel plate
and the timber debris on the
nose of the pier.

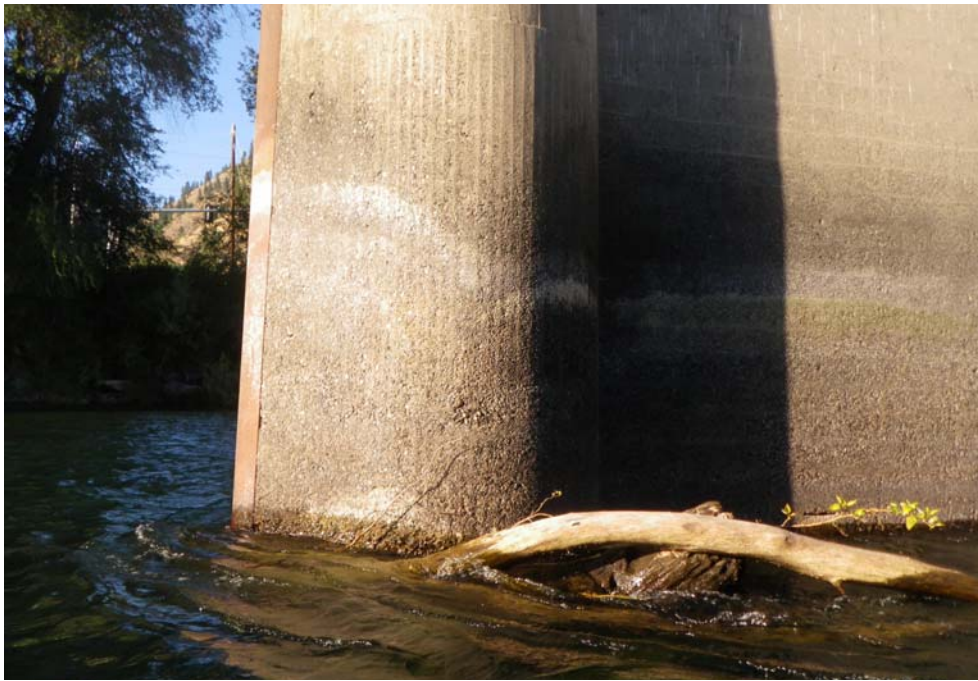
PHOTO No. 3: Pier 5, Looking North - Inspection of the leading edge of the pier found the steel plate to be well secured and evidence of minor abrasive scale on all concrete surfaces exposed to flow.

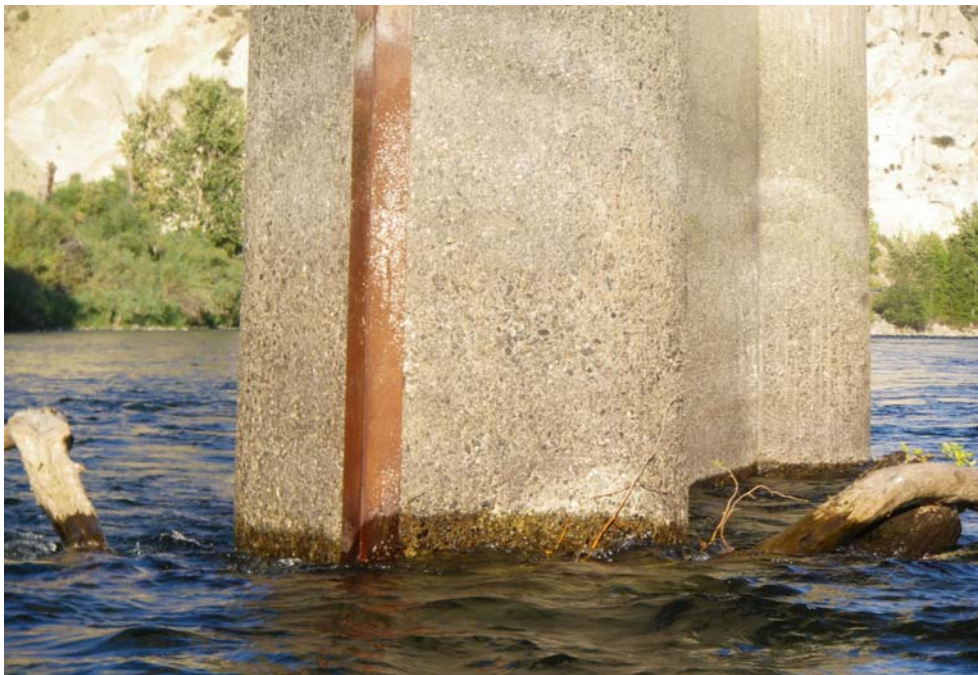
PHOTO No. 4: Pier 5, Upstream End - Note the good condition of the concrete and the embedded steel nose plate. Also note the large diameter timber debris that is trapped at the nose of the pier.

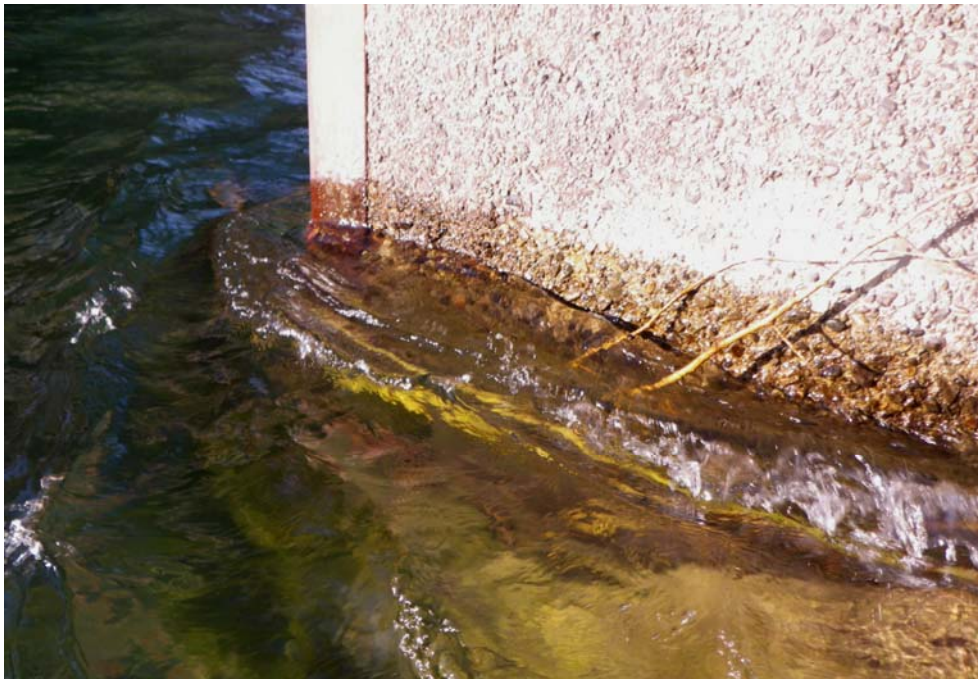
PHOTO No. 5: Pier 5, Upstream End, Close-up - Note the minor abrasive scale at the waterline. This area was noted to have sustained the most significant abrasive scale.

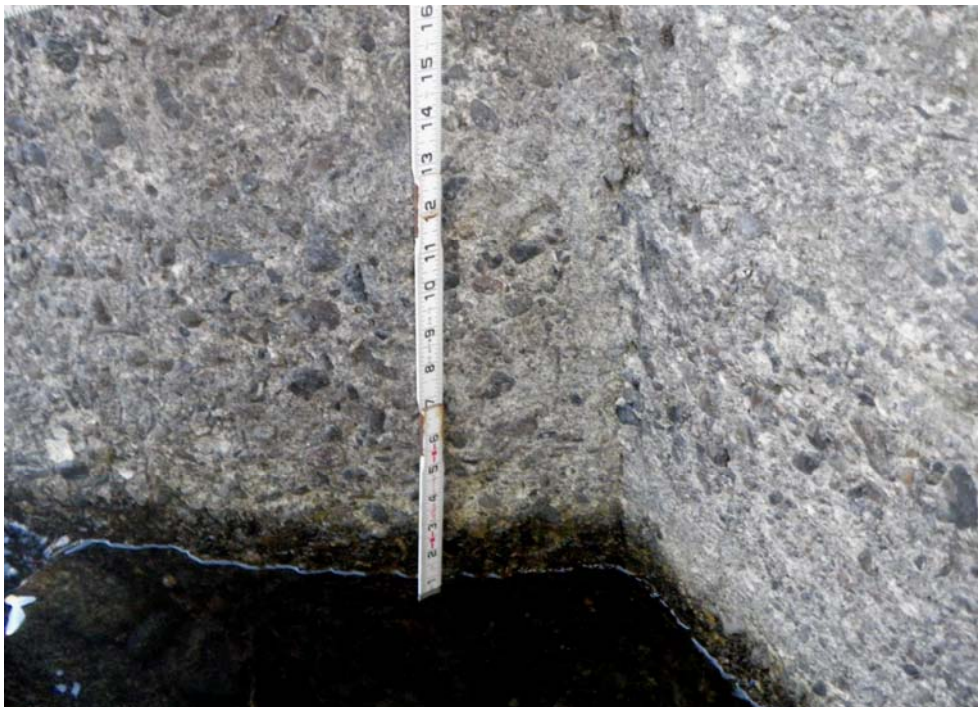
PHOTO No. 6: Pier 5, North Side - Note the good condition of the concrete in this area where the upstream column meets the web wall.

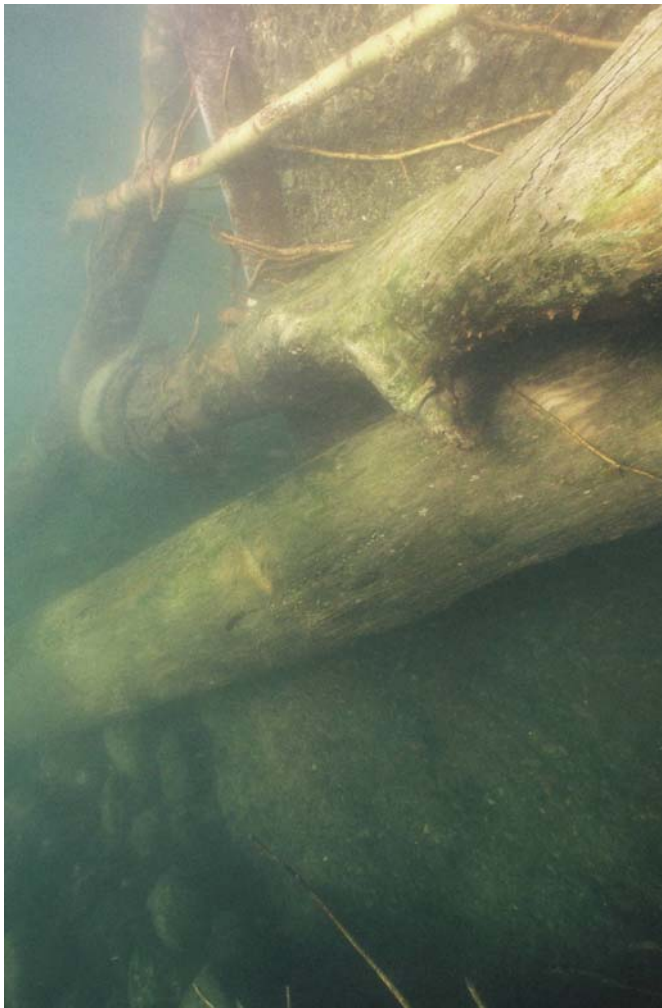
PHOTO No. 7: Pier 5, Upstream End - Note the embedded steel nose plate behind the build-up of timber debris at the upstream end of the pier. Also note the good condition of the submerged concrete and the rock and gravel bottom evident beneath the debris.

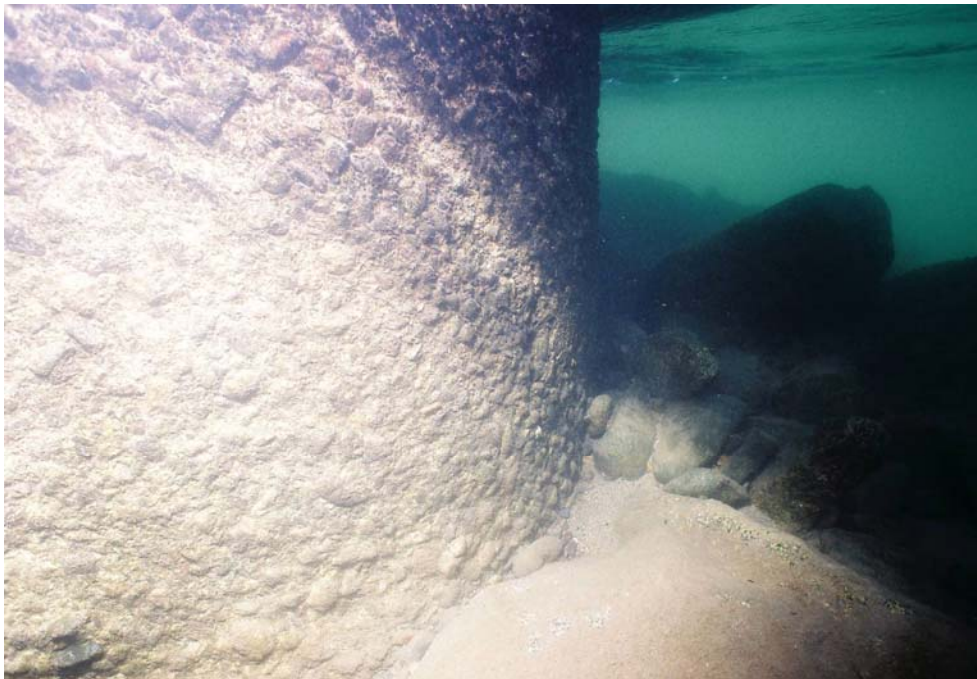
PHOTO No. 8: Pier 5, Downstream End - Note the good condition of the submerged concrete and the rock, sand and silt bottom composition.

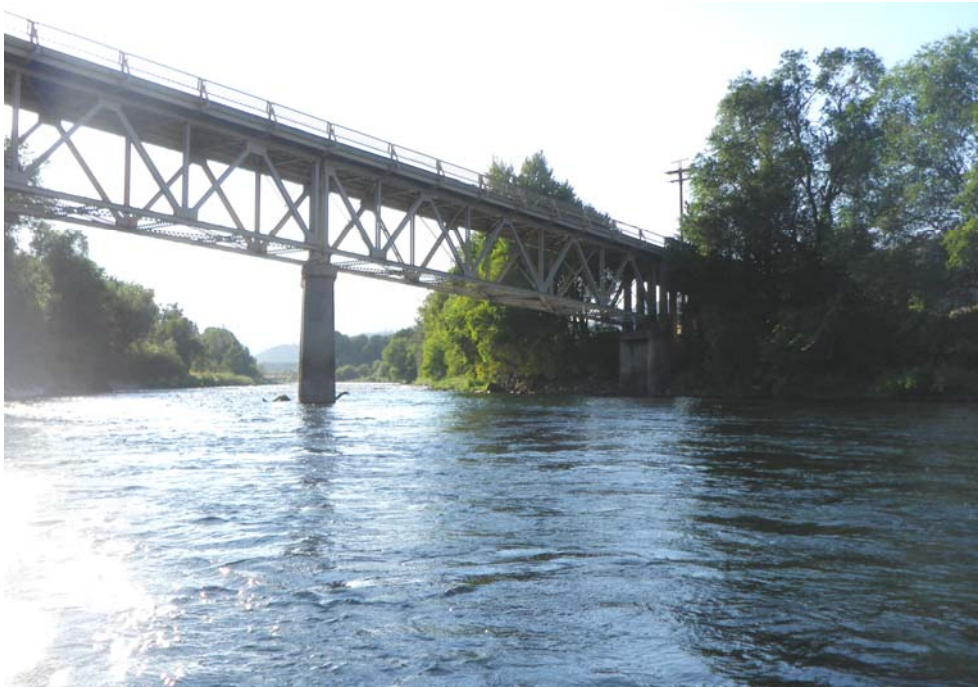
PHOTO No. 9: West Cashmere Bridge, Looking West - Note the well vegetated shoreline on both banks downstream of the bridge.
