Project No.: 170566

August 29, 2018

Re: Section 16 and 17 Upper Wheeler Road Reconnaissance and Planning-Level Geotechnical Considerations—Revised

Re: **Slope Stability Reconnaissance**

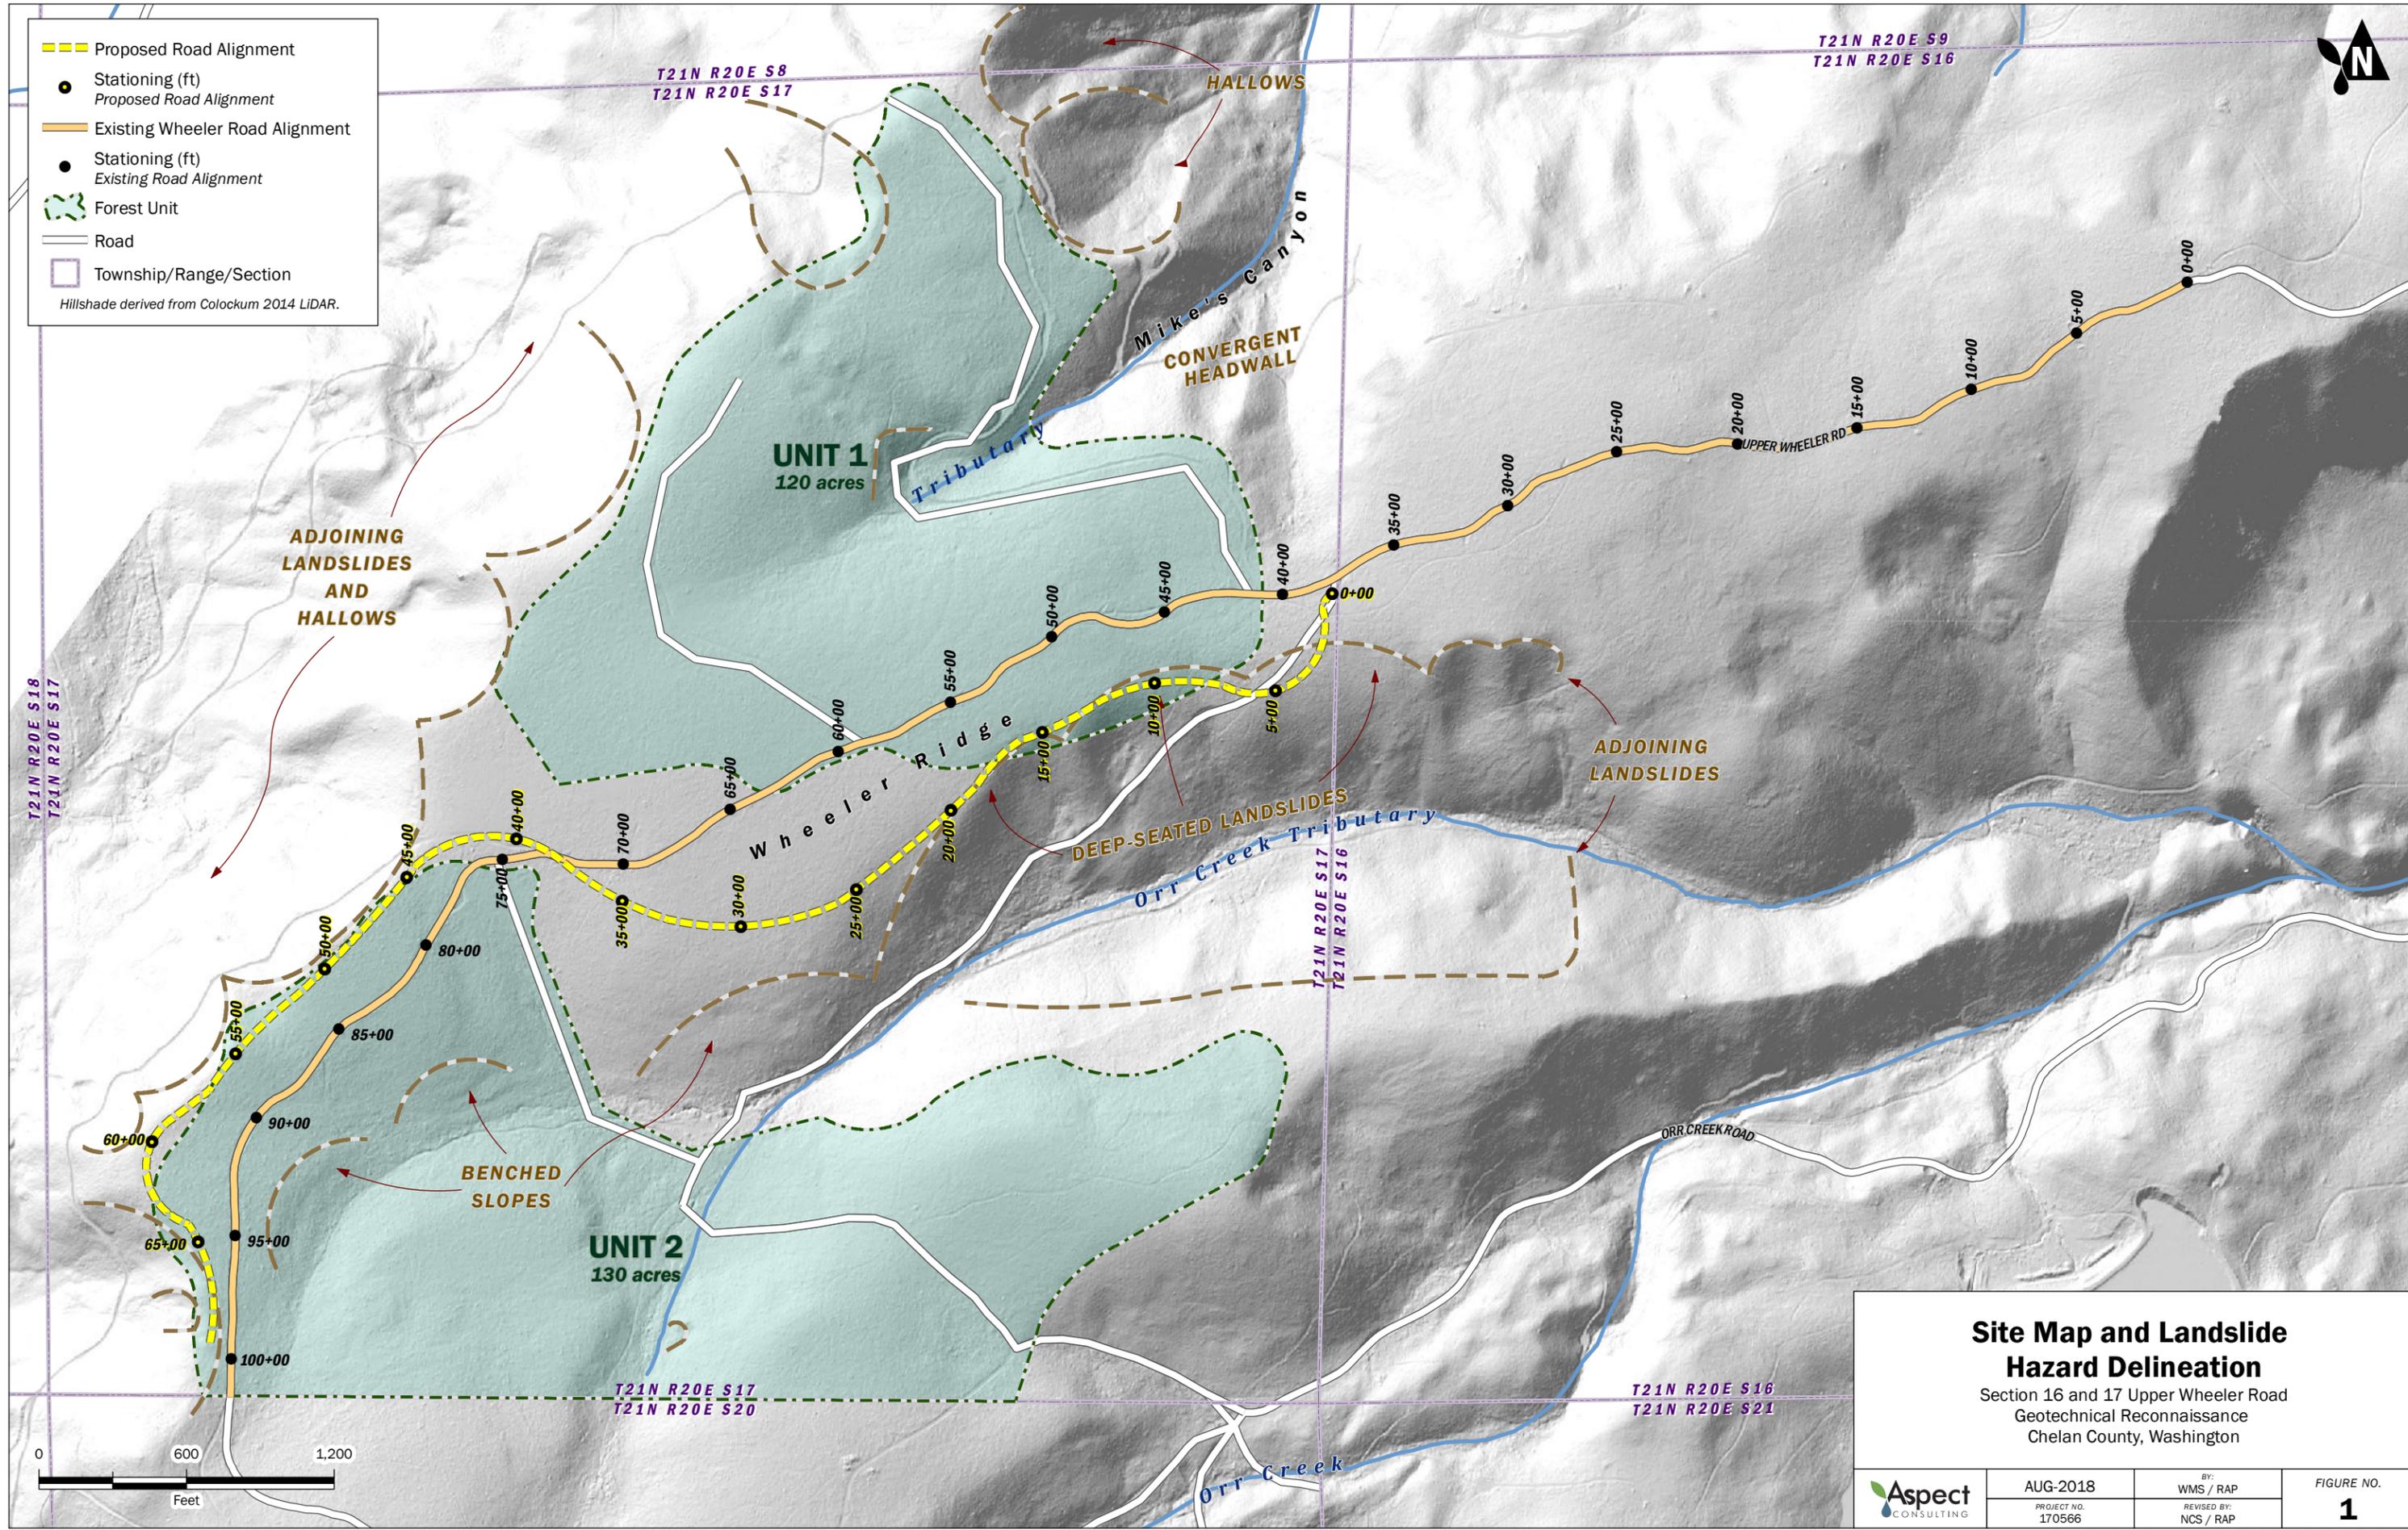
Site Map and Landslide Hazard Delineation Section 16 and 17 Upper Wheeler Road Geotechnical Reconnaissance Chelan County, Washington		
	AUG-2018 PROJECT NO. 170566	BY: WMS / RAP REVISED BY: NCS / RAP
		FIGURE NO. 1

In addition to the landslide feature delineation presented in the Slope Stability Reconnaissance (Aspect, 2017), we also observed some additional surficial indications that past landslide activity or slow ground creep may have occurred to the north of delineated Deep-Seated Landslides shown on Figure 1, and between Proposed Road Alignment Station 2+00 to 25+00. These indications consist of tilted or pistol-butted evergreen trees and areas of depressed or hummocky terrain. These surface features in our opinion, indicates landslide activity or ground creep has occurred consistent with those described in the Slope Stability Reconnaissance (Aspect, 2017).

Due to the proximity to delineated landslide activity, it is our opinion that there is an increased, moderate likelihood that landslide activity will negatively affect the Proposed Road Alignment

from approximately Station 0+00 (start) to 30+00, and 42+00 to 69+00 (end) over the design life of the road.

We estimate landslide or ground creep-induced movement could manifest as tension cracks and depressed/sagging areas, or as vertical movements causing offsets of the roadway. For these small movements, we anticipate that the roadway and drainages can be repaired/re-leveled with ongoing maintenance by WR after it occurs. A more extreme, but less likely, scenario is large-scale roadway movement on the order of several feet or more such that it might be most economical to WR to abandon the roadway and realign it further away from landslide activity.

We recommend WR frequently inspect the roadway alignment to identify areas and drainages that might require repair or re-leveling.

Similarly, we recommend the roadway realignment aim to limit the cuts and fills made to form a roadway prism to less than a few feet tall, with cut and fill slopes as flat as possible (our initial consideration is 2H:1V [horizontal:vertical] or flatter). This may not be possible in all areas, and slopes steeper than about 2H:1V should be addressed and evaluated in tandem with the project civil engineer (SCJ Alliance) on a case-by-case basis during the design-level phase.

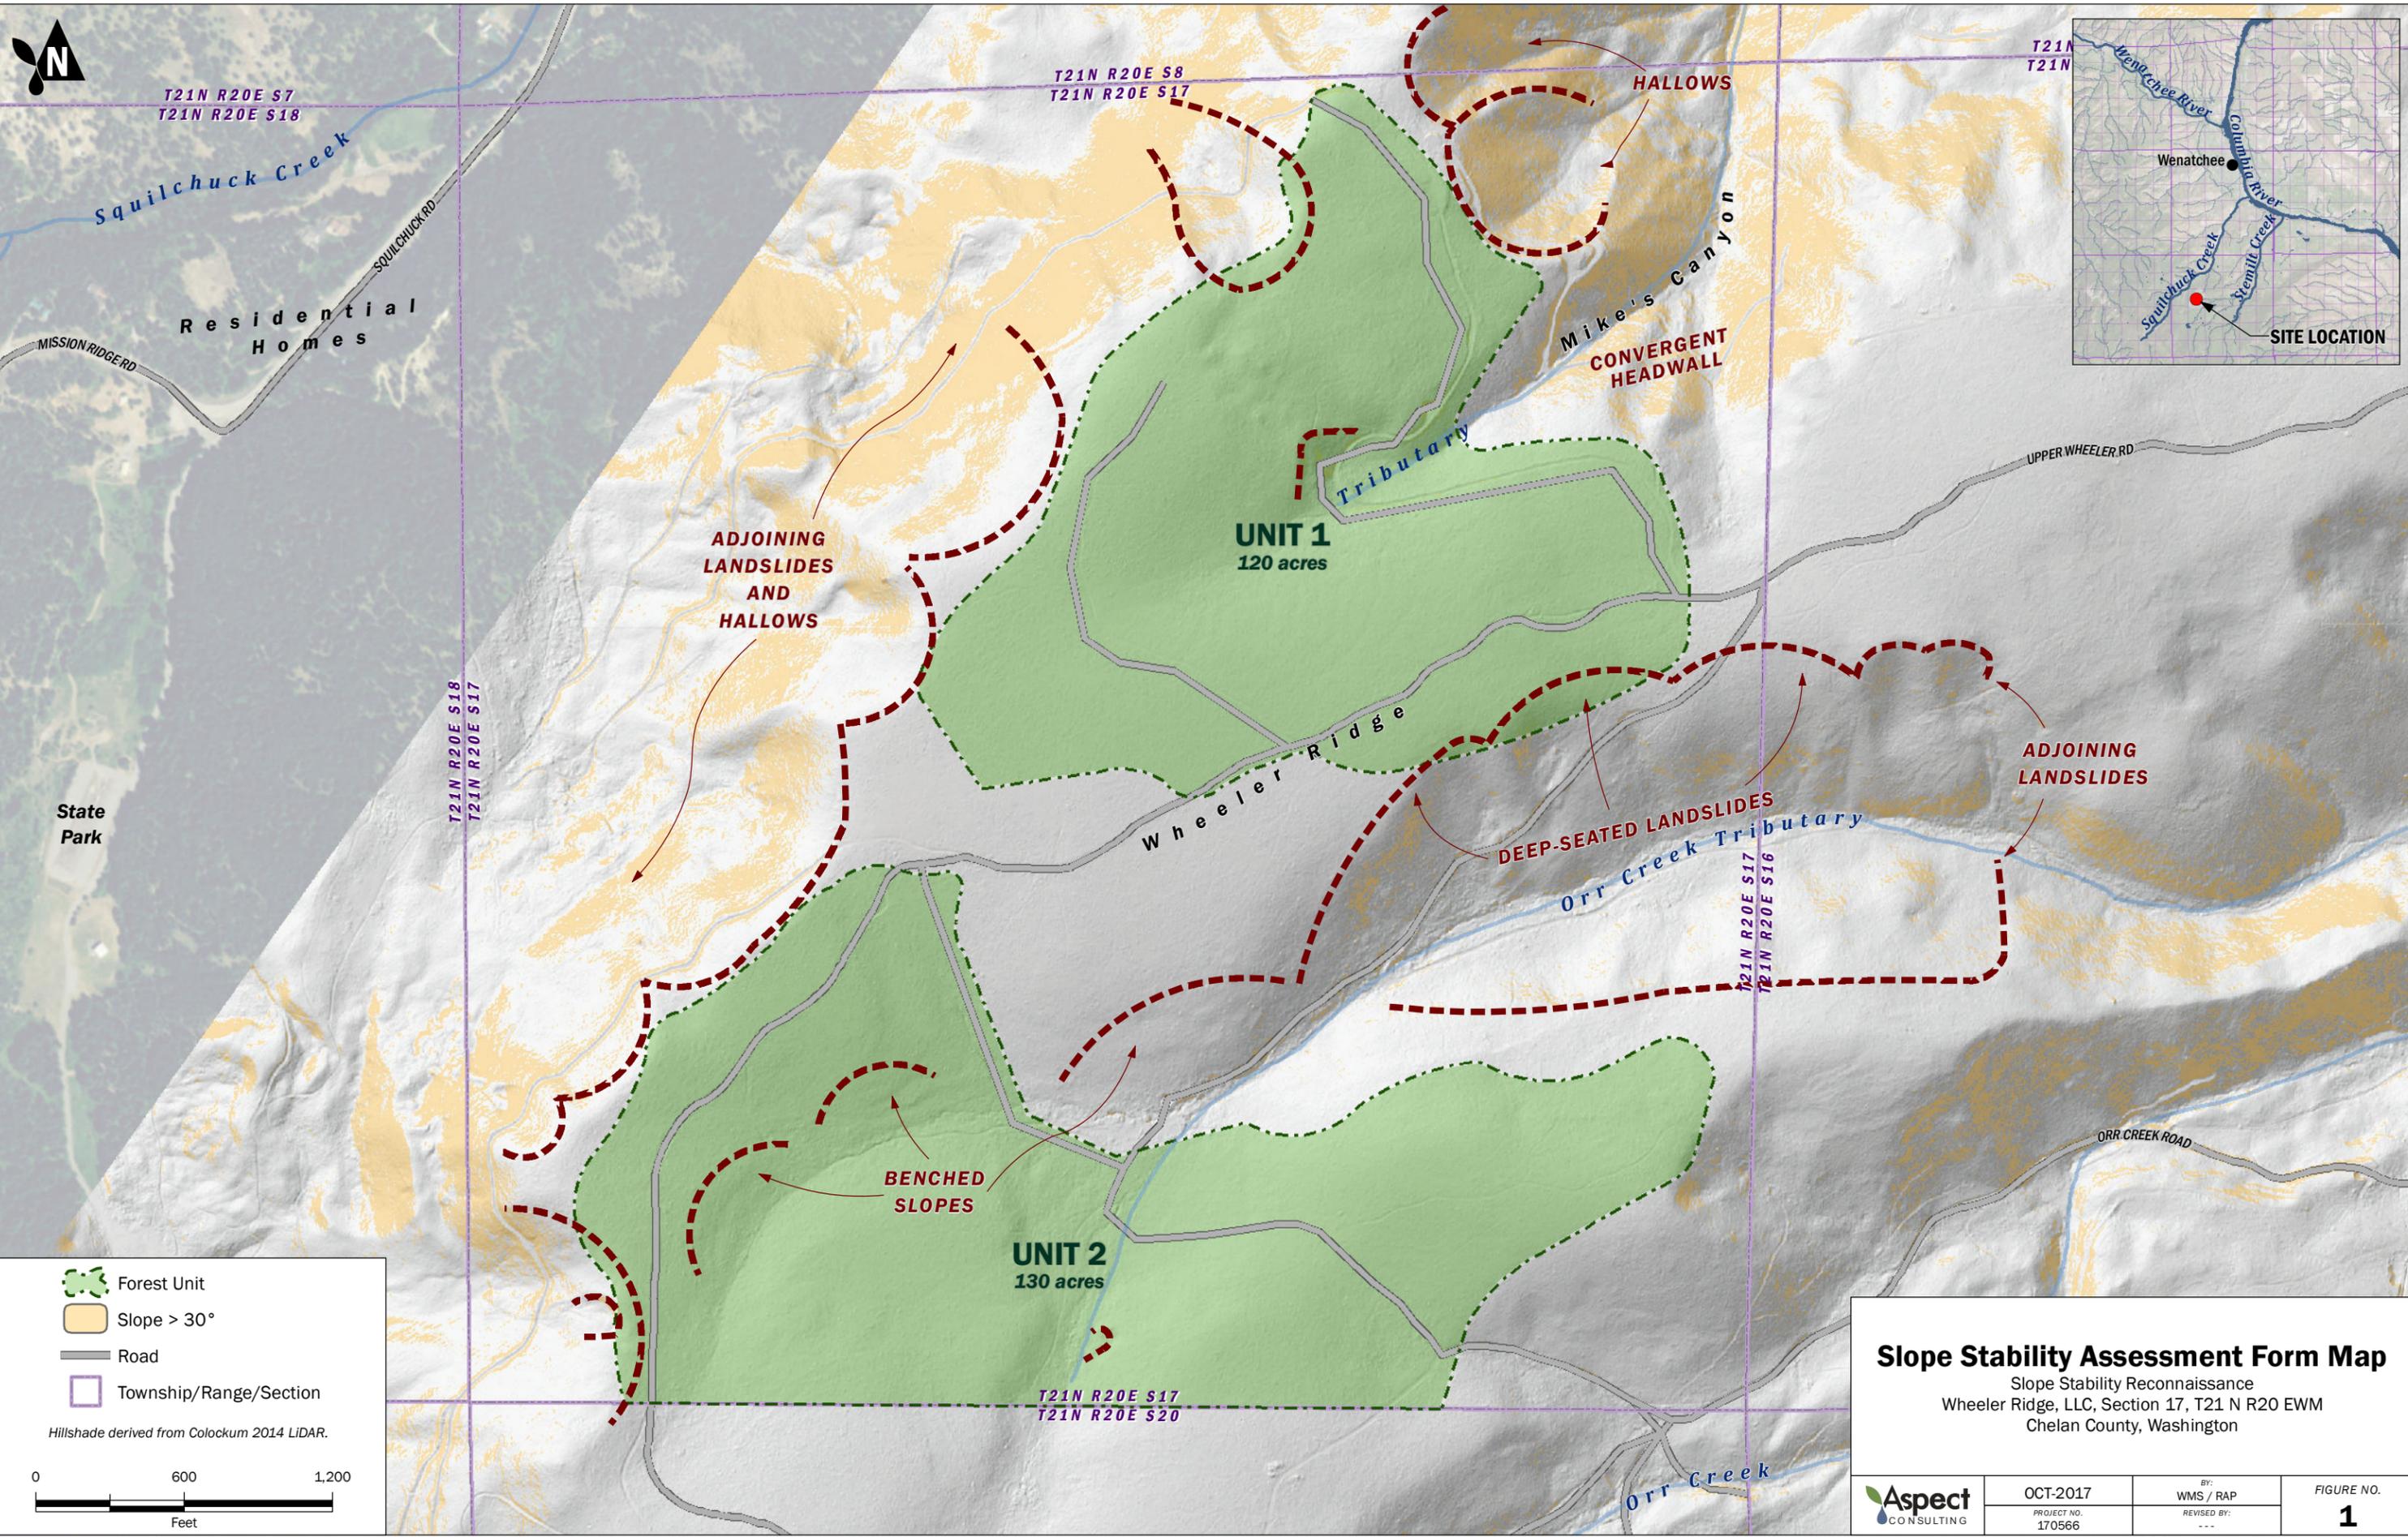
Slope Stability Assessment Form Map

The Site shows signs of past slope instability resulting from natural processes. Past failures were observed on slopes of 20 degrees and greater within the geologic unit mapped as mass-wasting deposits. Figure 1 contains mark-ups showing locations where there is evidence of past instability or potentially unstable landforms. These are discussed below.

- **Northeastern corner of Section 17.** Steep slopes exceeding 30 degrees are present adjacent to the eastern boundary of Unit 1. A convergent headwall measuring about 1,000 feet across and one or two hollows and inner gorges are present in the upper reaches of Mikes Canyon along the eastern boundary of Unit 1. Within Unit 1, there is evidence of a small landslide measuring about 50 feet across located on the north sidewall of the tributary drainage to Mikes Canyon.

- **Northwestern third of Section 17.** Steep slopes exceeding 30 degrees are present adjacent to the western boundaries of Units 1 and 2. These slopes drop about 800 feet vertically from Wheeler Ridge to the bottom of the Squilchuck canyon. Several hollows up to between about 100 and 500 feet across are present in the upper portion of the canyon wall along the northwestern boundaries of Units 1 and 2. The upslope extent of these hollows terminates at or slightly within the boundaries of the forestry units.

- **Orr Creek Tributary.** Within Unit 2 in the upper reaches of the Orr Creek tributary, slope failure was observed along the sidewalls of the drainage on slopes of about 20 degrees. On the northern sidewall, benched terrain suggests slow moving creep processes. On the southern sidewall, a small rotational landslide measured about 50 feet across. Further down the drainage in the region between Units 1 and 2, multiple slope failures were observed in sidewalls having slopes of 30 degrees or more. Several adjoining landslides were observed on both sides of the drainage. These landslides lie adjacent to the southern and northern boundaries of Units 1 and 2, respectively. At least two deep-seated rotational slides measuring about 200 feet across were observed with toes extending to the bottom of the drainage. Slope angles at the toes of slides on the Site are less than 33 degrees.

The primary mechanism for slope failure in the Site vicinity is oversteepening of sidewalls resulting from long term drainage incision. No active or recent slope failures were observed. The age of past instability is inferred to be on the order of hundreds of years based on the roundedness of scarp surfaces and the presence of well-developed soils and vegetation (trees) on the landslide deposits. While no recent slope failures were identified, the mechanism driving past slope failures is ongoing. Future slope failures could include reactivation of old landslides and initiation of new ones, especially during periods of wet weather or seismic activity.

- Minimize clearing native landcover on slopes of 20 degrees or greater. Where timber must be harvested to support adequate sunlight adjacent to orchard margins, we recommend maintaining natives grass, shrub, and soil to minimize runoff, erosion, and infiltration into the subsurface. Replant disturbed groundcover immediately after clearing.

- Implement adequate roadway drainage design. When constructing roads, use appropriate best management practices (BMPs) for drainage design to minimize saturation of soils on steep slopes and erosion. Designs should consider constructing roadside ditches on the uphill side and providing multiple, properly sized culverts to maintain natural drainage courses avoiding concentrating flows on steep slopes. Culverts should be maintained to avoid clogging/overtopping. Culverts within the Orr Creek tributary should be properly sized and water courses returned to their natural channels to minimize erosion and soil saturation.

- Avoid large fills and steep cuts near steep slopes. Large soil stock piles should not be placed adjacent to the tops of steep slopes. Avoid filling depressions near the tops of steep slopes. In some cases, these are the uppermost expressions of hollows resulting from previous slope movement. Filling these depressions could reinitiate slope movement.
