Re: Draft Environmental Impact Statement, Mission Ridge Expansion Master Planned Resort

In the following pages I comment on landslide hazard in the proposed development and its treatment in the DEIS. Topics are: (1) landslides at the site of the proposed development; (2) discussions in the DEIS of landslides; (3) planned wastewater disposal and snowmaking will exacerbate the landslide hazard; (4) inadequate mapping of surficial geology; (5) analysis, evaluation, and monitoring are not mitigation; (6) significance of block fields; and (7) how the magnitude and frequency of landslide hazard might be evaluated. I also comment on (8) geology beneath the proposed public access road.

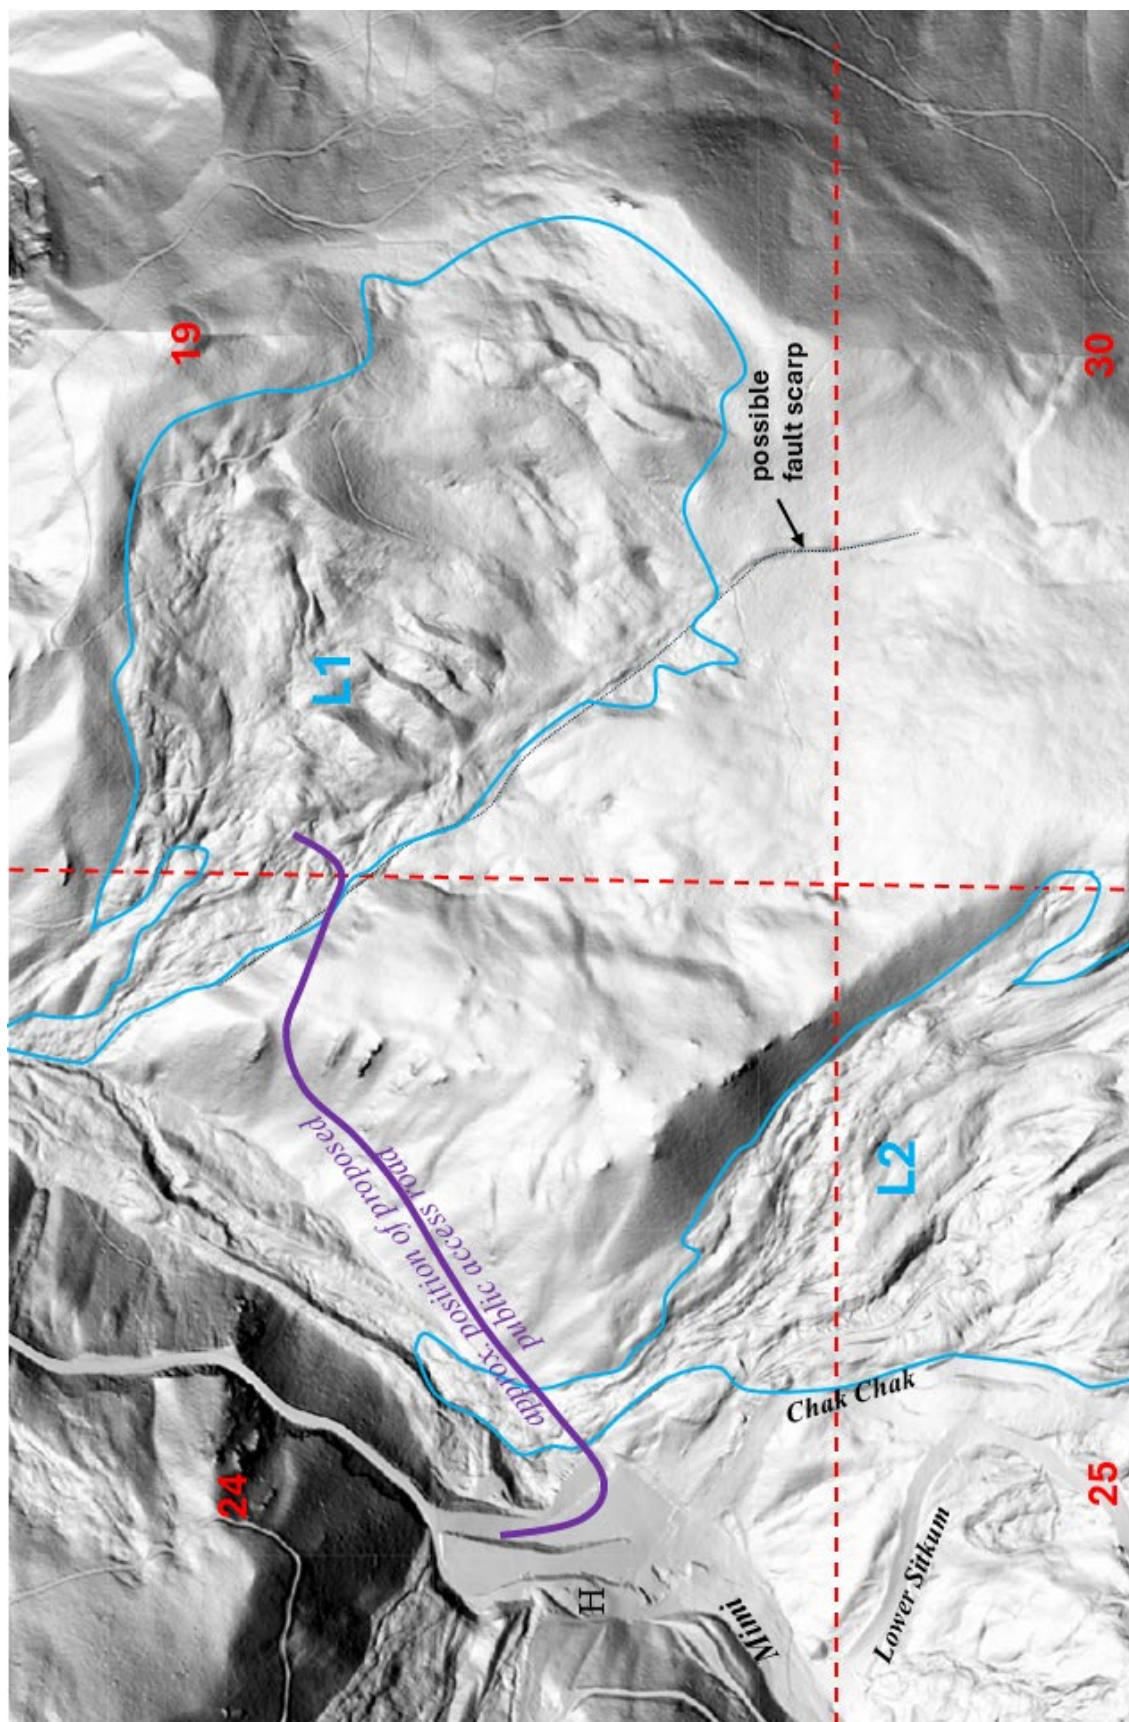
Figure 1. Image-map of Mission Ridge Resort base area and area of proposed expansion. Shows locations of landslides L1 and L2 and approximate location of proposed public access road. H is location of Hampton Lodge. Section lines are approximately located. Width of view is about 1.4 miles. Base image from Washington Lidar Portal, <https://lidarportal.dnr.wa.gov/>.

When I look at lidar topography ([Washington Lidar Portal](#)) (Fig. 1) of the area of the proposed Mission Ridge expansion, I see two significant landslides. The first landslide (L1) occupies much of the W½ of Section 19, T21N R20E and extends downhill into the eastern edge of Section 24, T21N R19E. Most of the development (commercial buildings, residences, maintenance facilities, residential access roads, utility distribution lines) proposed as part of the Mission Ridge expansion is in this landslide. Tabor and others (1982) fairly accurately mapped this landslide as unit Qls (Landslide deposits, undifferentiated). The morphology of this landslide is complex: large rotational blocks in its upper region transition downslope into debris flows that reached Squilchuck Creek. The SW margin of the landslide may be located along a recent fault (Fig. 1).

The second landslide (L2), partly mapped in Fig. 1, is mostly in the NE¼ of Section 25, T21N R19E, east of Chak Chak ski run, and extends downhill to the NW into the SW¼ of the SE¼ of Section 24. The proposed public access road to the development crosses this landslide. Tabor and others (1982) mapped most of this landslide as unit Qrg (Rock glacier deposits—Angular locally derived boulders forming bulbous tongue) and mapped the lowermost part as Qa (Alluvium).

Previous mapping (Tabor and others, 1982) and my field observations (Fig. 2) suggest much of the proposed public access road route (Fig. 1) is underlain by Eocene fanglomerate and sandstone. Lidar topography shows ribs on the slope above that I interpret as outcrops of resistant beds of sedimentary rock. Orientations of the ribs are consistent with the NNW strike and steep NE dip of bedding I measured in outcrop along the pioneer road. Seismic surveys and exploratory borings by GNN confirm that these are reasonably competent rocks. However, unlike granitic intrusive rocks (which is what GNN identified them as), fanglomerate and sandstone are likely to be interbedded with layers of less competent mudstone and siltstone.

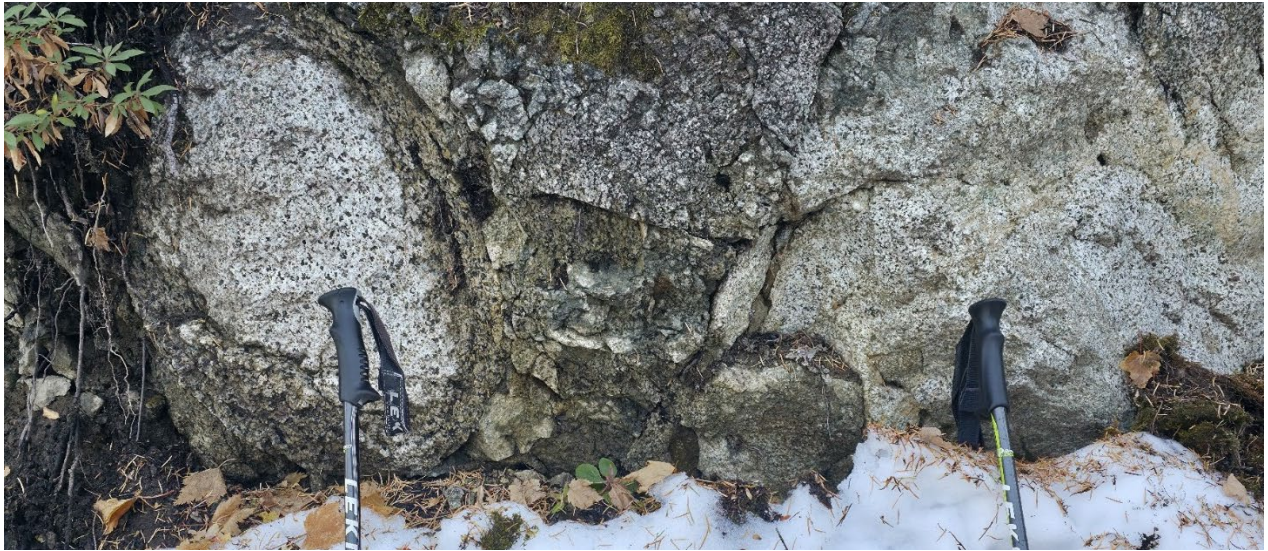
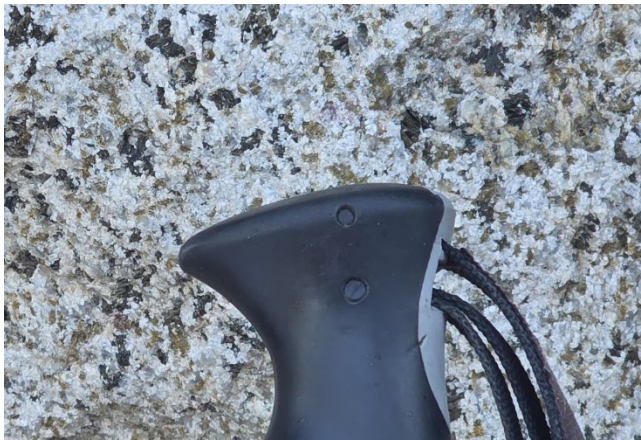
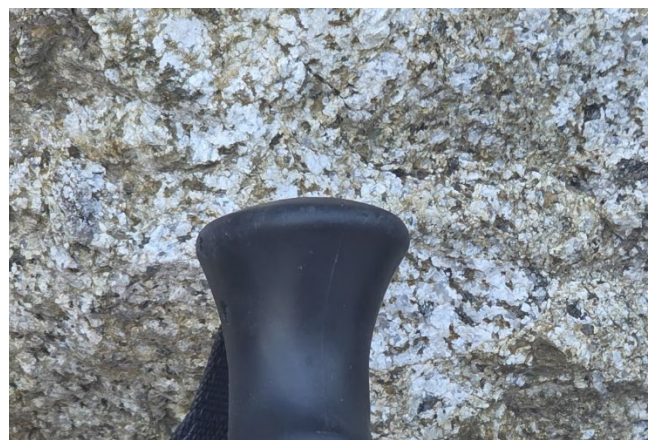
Figure 2. Outcrop of boulder fanglomerate along pioneer road in vicinity of proposed public access road. Two granitic boulders are separated by matrix of sand- to pebble-sized grüßy debris. View to SE.

Close-up views of left and right boulders. Note differences in texture that demonstrate these are not a single intrusive mass.

**In summary**, at least part of L1 is recently active and conditions within and beneath it are unexplored. L2 is "potentially active" and competent material is at least 50 ft below ground surface. I have examined outcrops along the pioneer road and the "granitic rock" noted by GNN along the NW-facing slope between L1 and L2 is fanglomerate (Fig. 2) that is likely to contain weaker interbeds of siltstone and mudstone.
