Steffen's Meadow Restoration and Planting Plan
Chelan County Natural Resource Department, Washington Department of Ecology
SEATHA-VER2-ChCoNR-00019

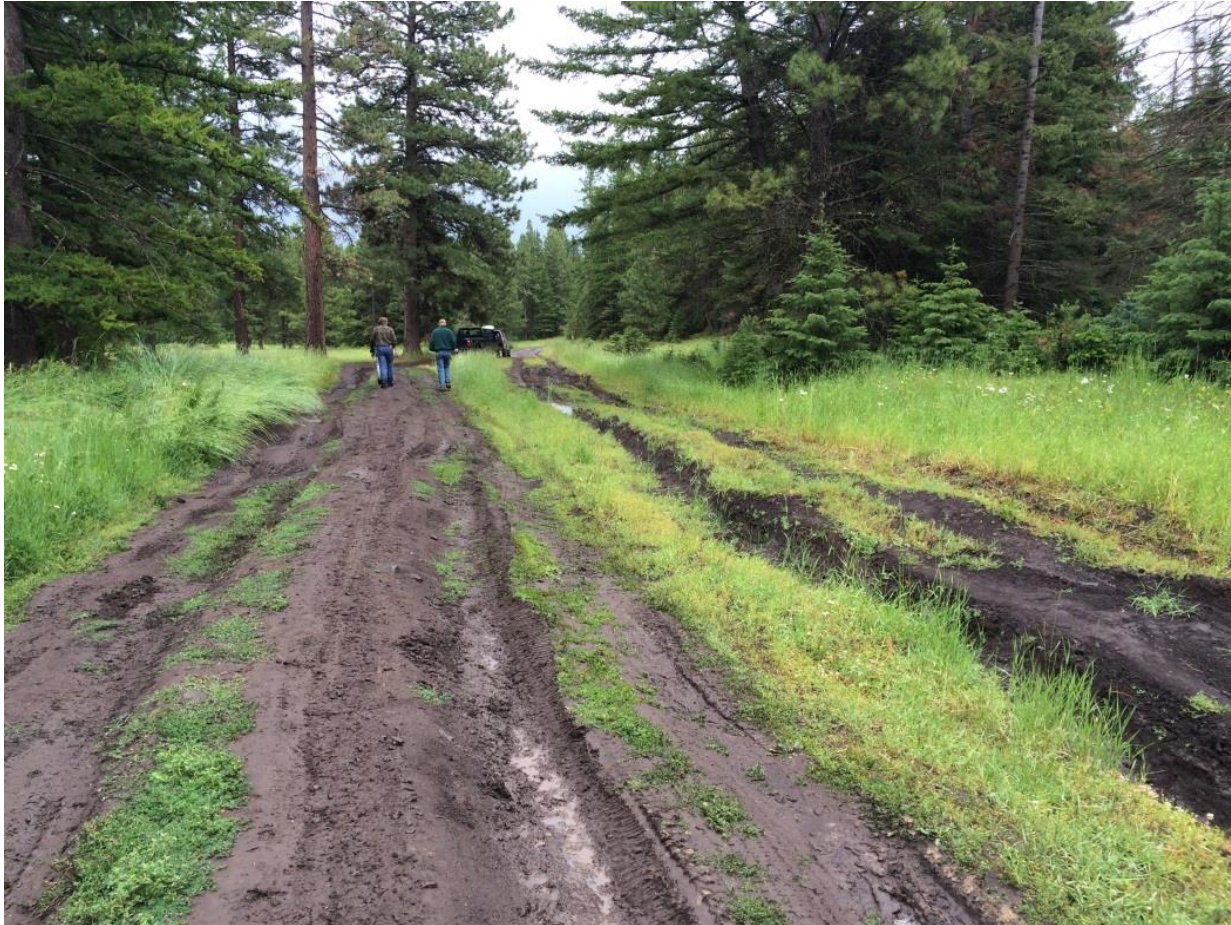
Green Dot Road causing damage in Steffen's Meadow. Photo: Erin McKay, 2016

Steffen's Meadow is a beautiful meadow/wetland that sees heavy damage from vehicle use, both on the Green Dot road and in the meadow. A creek intersects the meadow in one corner, and is diverted into a ditch along the outside edge of the road that parallels the meadow. The road along the meadow gets extremely wet and muddy (due to the proximity of the creek and the wetland nature of the meadow), and deep ruts result from vehicle traffic in the spring/early summer. As these ruts form, the road migrates farther into the meadow, resulting in a current road width of about three times the original road width. Additionally, illegal motorized vehicle use in the meadow has resulted in very deep muddy ruts in the meadow itself. Despite recent emphasis patrols by WDFW staff to dissuade this activity, damage to the meadow is still occurring, with lasting impacts.

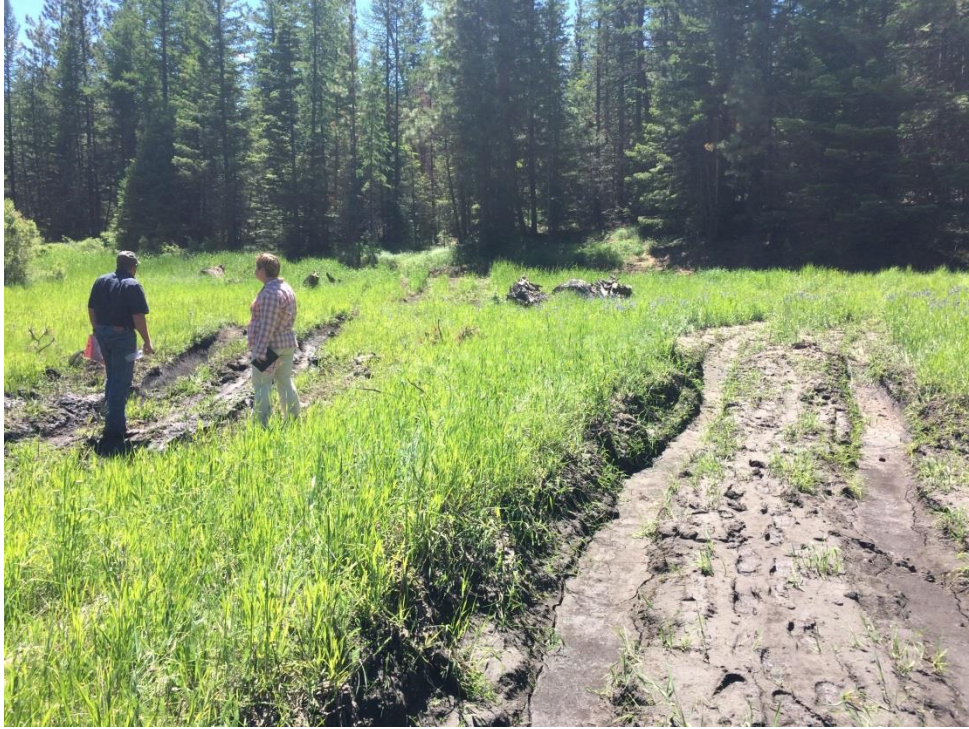
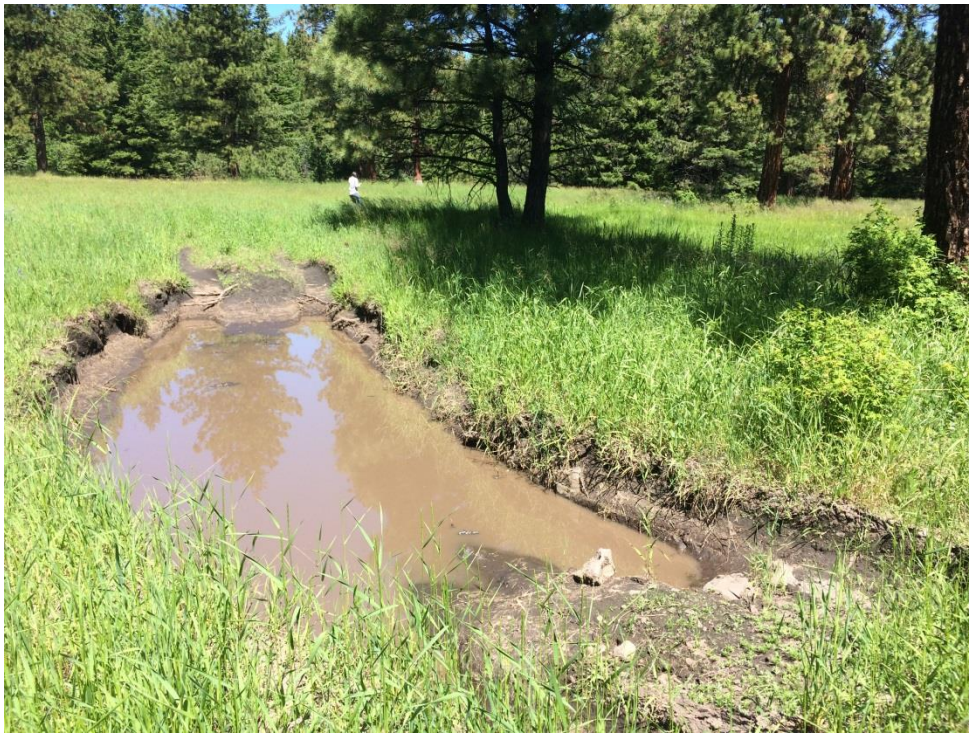
Ruts caused by illegal 4x4 activity in the meadow. Photos: Erin McKay, June 2017

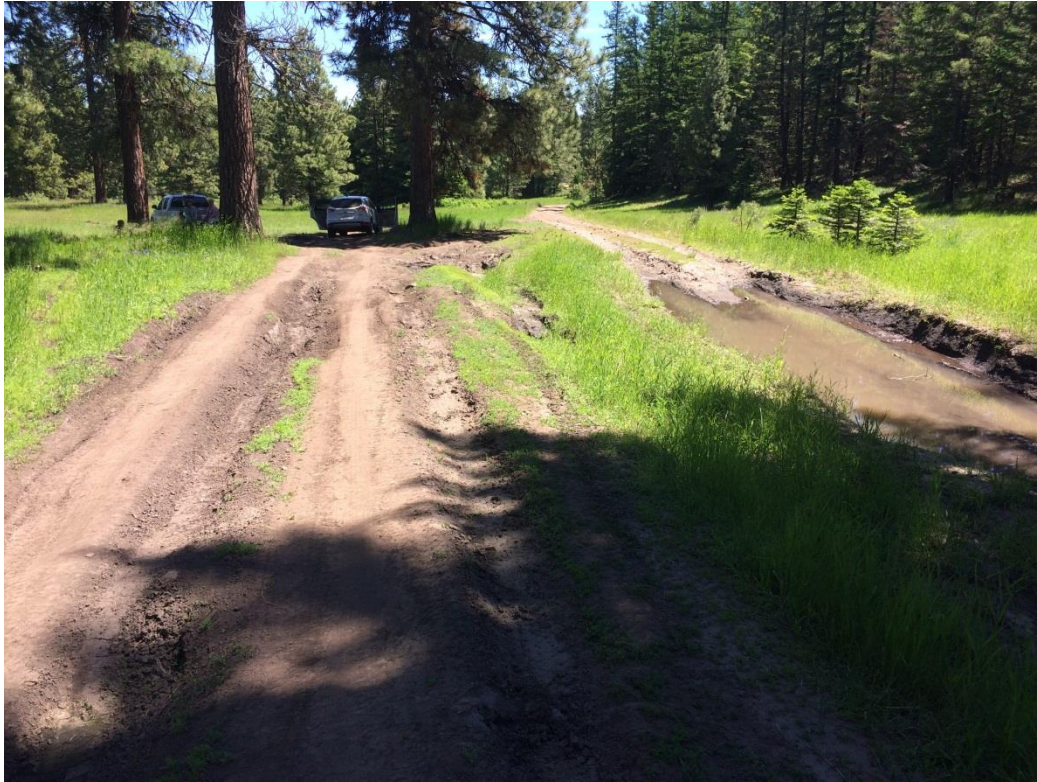
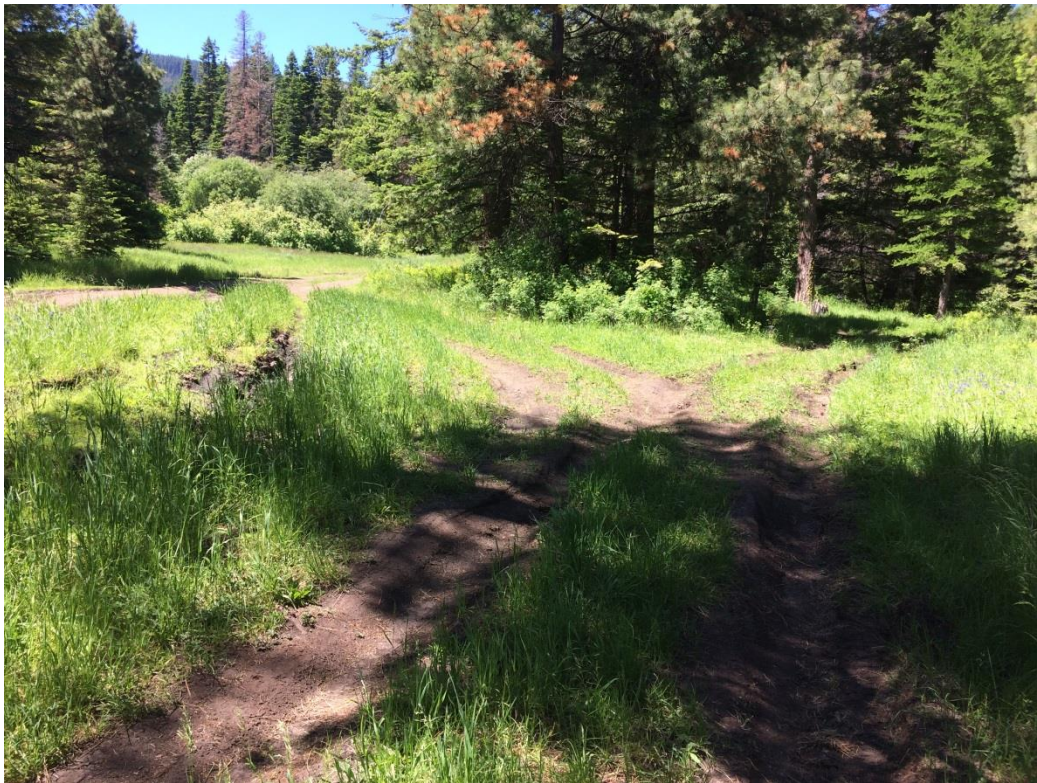
Green Dot Road along the edge of meadow, migrating further into meadow as road becomes too wet/muddy to drive. This section of Green Dot road will be routed away from meadow. June 2017.
