LARSEN CREEK PRELIMINARY DESIGN

Low-Tech Process-Based Restoration

Reid Camp, Michael Briggs, and Nicole Farless
Cramer Fish Sciences
Moscow, ID 83843

June 2024

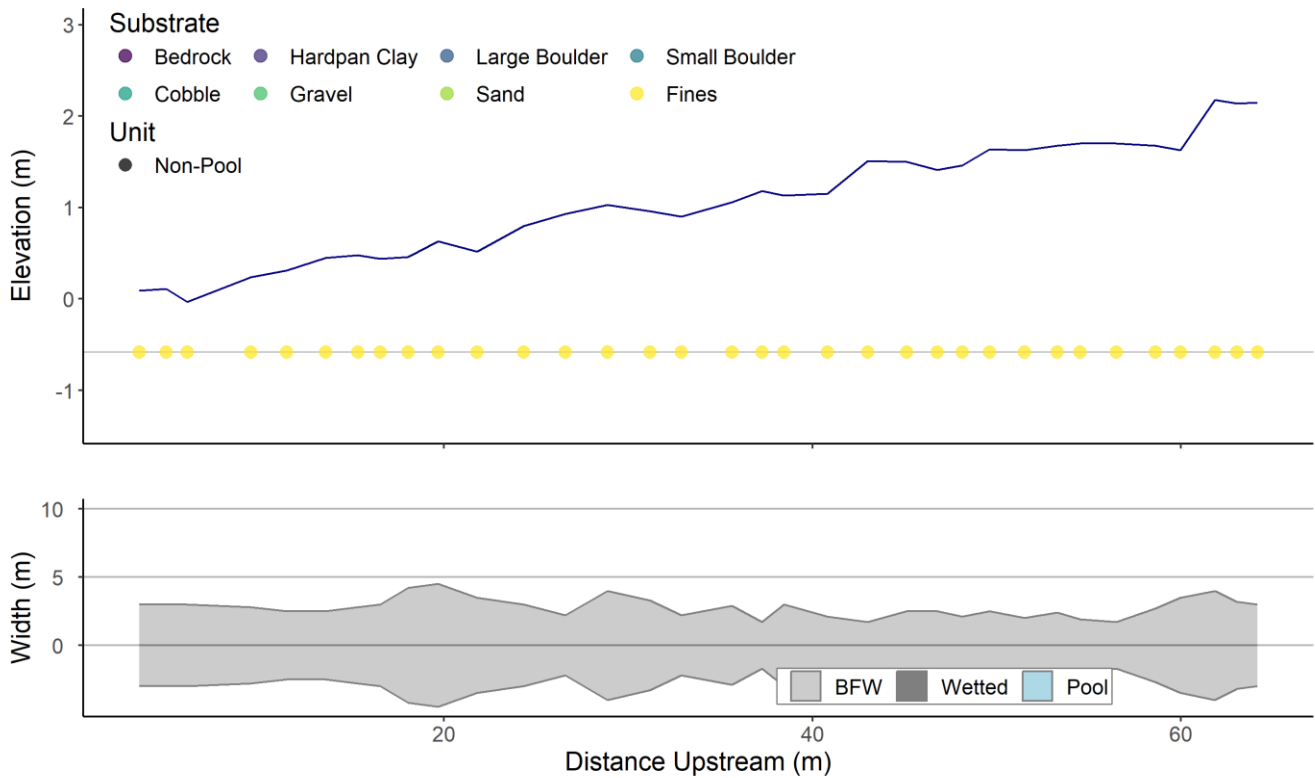
Figure 13. Long profile survey results in Complex 1 of Larsen Creek.

During the field-based design, on September 14th, 2023 we also completed several long profile surveys to capture streambed gradient, recording elevation at each inflection point. The long profile data gathered in the field was used to supplement remote sensing data and provided additional insight into fluvial processes at a finer scale than the current LiDAR can provide. At each point, bankfull width, wetted width, depth (if wetted), stream bed elevation, channel unit (if wetted), presence of large wood, and dominant substrate were recorded. The profile follows along the deepest portion of the stream,

yielding a two-dimensional longitudinal profile of streambed elevation and bankfull width (Figure 13 - Figure 16).

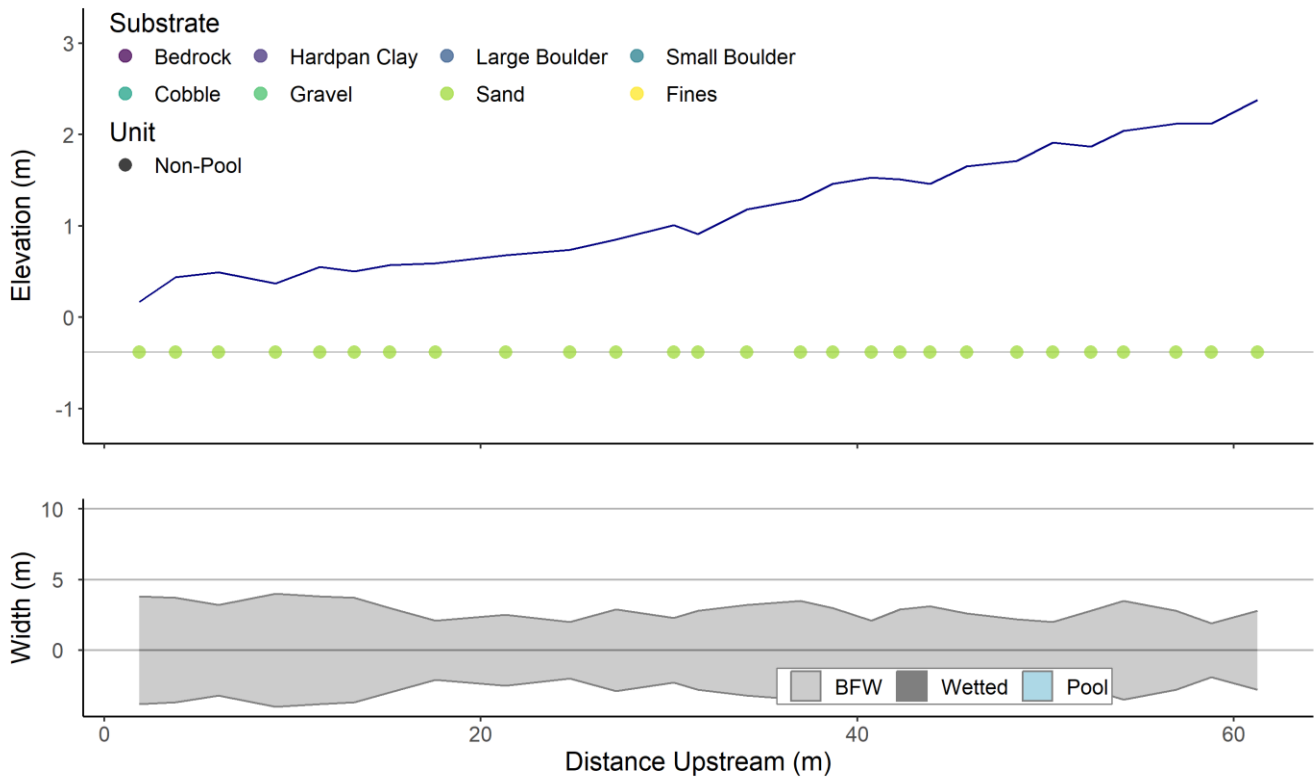
Figure 14. Long profile survey results in Complex 2 of Larsen Creek.

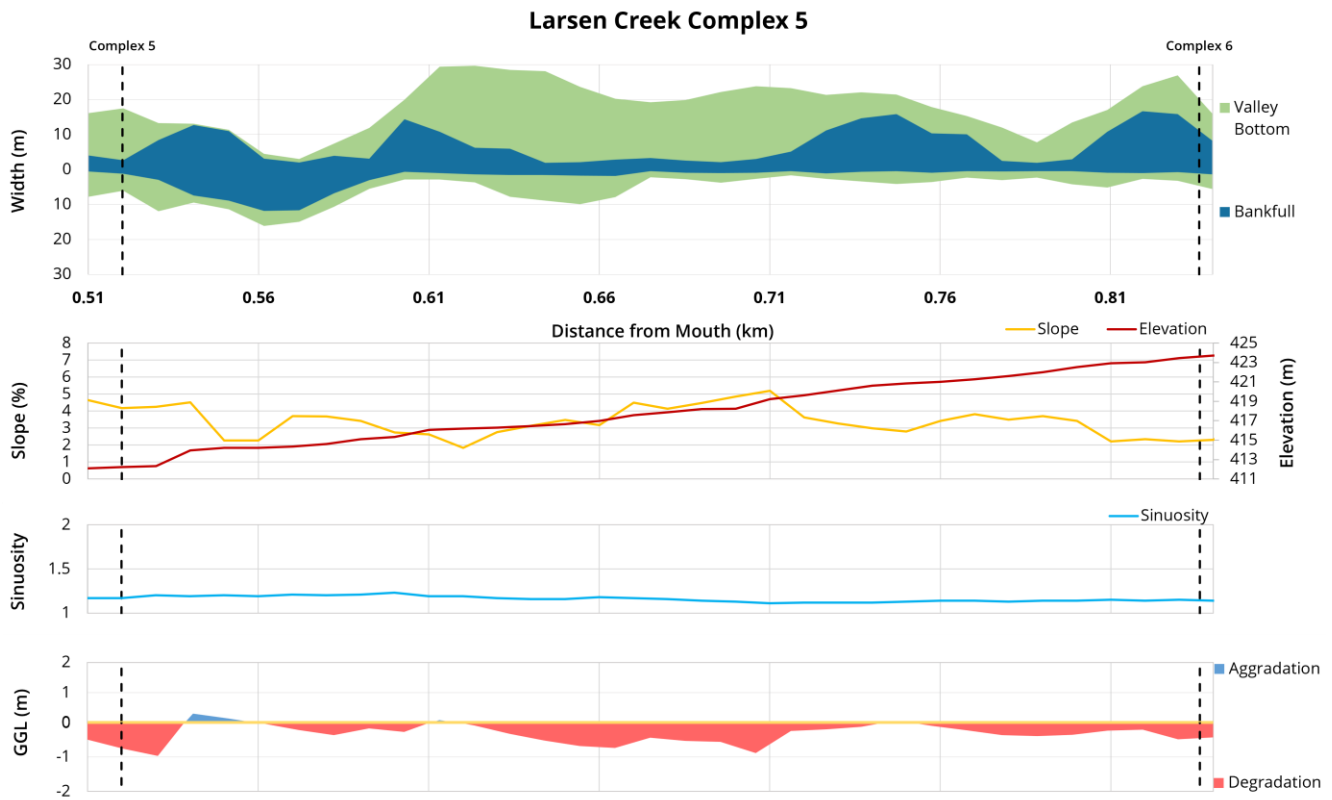
Figure 26. Long profile of geomorphic features and GGL results in Complex 5.

Complex 5 focuses on water and sediment retention. Complex 5 contains large areas of floodplain that are in equilibrium with the geomorphic grade line. While much of the channel in Complex 5 is incised (Figure 26), the locations where the channel is in equilibrium with the geomorphic grade line provide an opportunity for water storage using leaky dams and BDAs to capture the floodplain that is also in equilibrium. The placement of these leaky dams and BDAs was confirmed using the GGL results. For areas in need of aggradation, we recommend the combination of PAS and leaky dams to slow flows and aggrade the channel to eventually provide more access to the expansive floodplain in Complex 5.

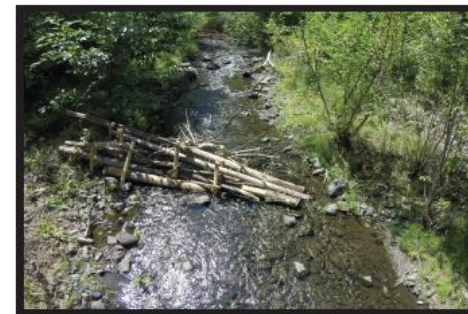
BANK-ATTACHED PALS • INDUCE MEANDERING • DEVELOP POOLS • SORT SEDIMENT • INCREASE HABITAT COMPLEXITY

EXPECTED GEOMORPHIC RESPONSES

- A. Deposition Upstream
- B. Deposition in Wake
- C. Deposition Downstream
- D. Deposition Overbank
- E. Erosion at Convergent Jet
- F. Erosion by Plunge Hydraulics
- G. Erosion Forming Chute
- H. Erosion of Bar Edge
- I. Erosion of Outer Bank

Figure 37. Typical structure schematic for a bank-attached post assisted log structure used to force a constriction jet.

The following section provides typical structure schematics for PALS, BDAs, leaky dams, and PAS areas. These schematics are meant to be used as a general guide when building structures to meet a general objective. Structures may be modified in the field during construction to fit local site conditions and optimize effectiveness. The number of posts and wood used, structure orientation and angle, structure type, height, width constriction, and location may all be adjusted during construction. Site conditions may also force alterations in the typical structure schematics. For example, boulders or bedrock may make driving posts impossible at the original location.
